## ADVISORY CIRCULAR 43-16A

# AVIATION MAINTENANCE ALERTS

ALERT  
NUMBER  
275

JUNE  
2001

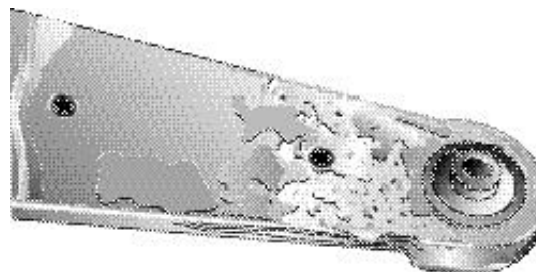
**Beech; Model 1900; Commuter; Flight Control Damage; ATA 5552**

During a scheduled inspection, the inspector discovered an elevator hinge bracket was corroded.

The hinge bracket (P/N 101-620011-3) was severely corroded, and the base metal was exfoliating. (Refer to the illustration.) The owner operates a fleet of five like aircraft. After this finding, he inspected all five aircraft, and four aircraft displayed similar defects. He recommended that other operators of like aircraft conduct a one-time inspection of their aircraft for similar damage.

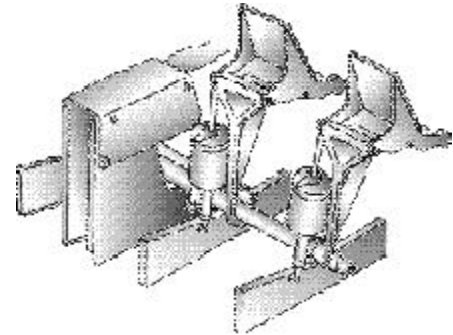
**CESSNA****Cessna; Model 150G; Rudder Pedal Wear; ATA 2720**

During an annual inspection, the technician found excessive wear associated with the pilot's rudder pedals.

The left side rudder pedal shafts (P/N's 1460501-21 and 0411778-2) were severely worn where the pins (P/N's MS24665-285 and MS20302-2C13) pass through to retain the shafts. (Refer to the illustration.)

The submitter stated he has found this type of wear on many occasions, and it is evident to him that this item is being overlooked during annual inspections.

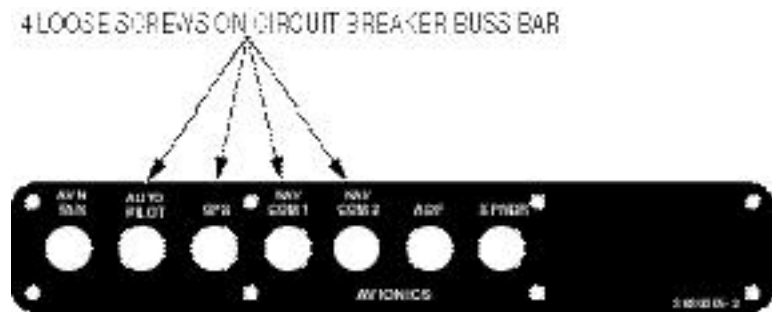
After some indepth troubleshooting, the technician found the “Audio Panel” communications selector was inoperative. He discovered four loose screws on the “Avionics” bus bar caused these electrical system anomalies. There was evidence of severe electrical arcing adjacent to each of the four screws. The loose screws were used to attach the “Auto-Pilot,” “GPS,” and “Nav/Com” 1 and 2 circuit breakers to the bus bar. (Refer to the illustration.)

The submitter stated there had been no electrical system installations or maintenance performed since the aircraft was delivered new. The “Avionics” bus bar is located behind the main wiring harness and is very difficult to inspect. He recommended that all operators of new like aircraft conduct a one-time inspection for the condition described here.

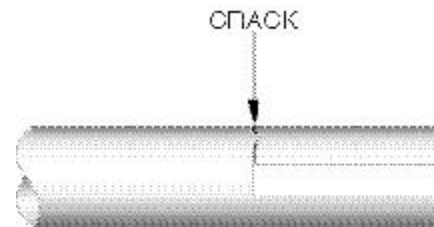
#### **Piper; Model PA 32R-300; Cherokee Lance; Defective Magnetos; ATA 7414**

During an engine runup at 2,000 RPM, the pilot noticed a 250 RPM drop on each magneto. The engine operation was very rough when operating on each magneto individually.

A technician investigated the magneto (Slick, P/N 6350 right and 6351 left) RPM drop and found a broken shaft on both the left and right magnetos. Both rotor shafts were broken at the base of the shaft slot. (Refer to the illustration.)

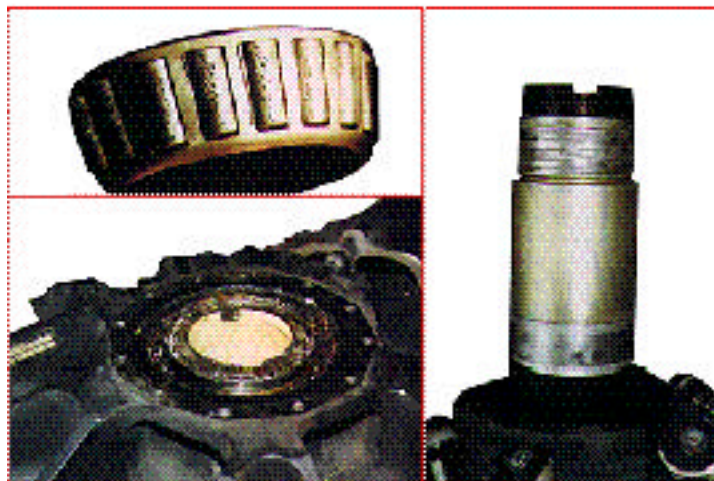
A postflight inspection revealed abnormally heavy collective forces were required to raise the collective off the “full-down” position. When the collective was cycled from full-down to full-up, a technician noticed the rotor head lifted approximately .5 inch and then slammed down with a loud clunking sound.

Technicians opened the rotor head and found the drive shaft locknut retainer screws were broken. The screws were hanging from the safety wire and were still attached to the heads. The drive shaft flange inner surface displayed score marks produced by the loose screw

heads. The retainer was no longer engaged with the rotor mast, and the rotor head locknut (Jesus nut) had lost torque. The locknut was backed off to within one thread on the top of the mast. The broken retainer screw shanks remained in the locknut and were sheared off even with the top of the locknut. Collateral damage was found on the side of the locknut bearing against the grease-seal retainer and the locknut was seized to the seal retainer. The bottom side of the grease-seal retainer was galled and scored where it was spinning on top of the bearing. The cone bearing was damaged by contact with the grease-seal bearing surface. The rollers in the cone bearing displayed evidence of metal fatigue, and pieces were missing from numerous rollers. Also, the bearing is discolored from apparent heat damage. The bearing race, pressed into the rotor head, is also scored and discolored.

In the opinion of the submitter, this damage resulted from material failure of the cone bearing, which led to overheating and increased turning resistance and wear. As the bearing developed increased play, the torque on the rotor head locknut was reduced and allowed the bearing to spin on the mast.

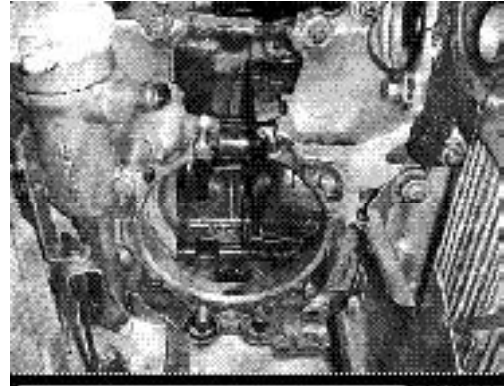
During cruise flight, the pilot heard a loud abnormal sound from the right engine and the engine failed. The pilot was able to make a safe single-engine landing and reported the incident to maintenance personnel.

While inspecting the engine, the technician discovered the number 2 cylinder connecting rod was broken loose from the crankshaft, and the engine case was broken adjacent to the cylinder attachment. (Refer to illustration number 1.) The cylinder separated from the case and was contained by the cowling. The connecting rod penetrated the upper cowling.

The only suggestion offered by the submitter was to ensure hardware is properly torqued and safetied during assembly.

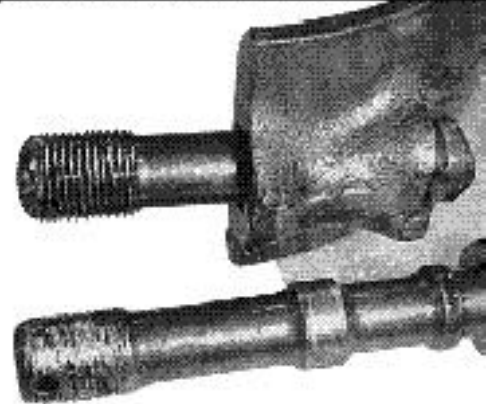
After collecting all the broken parts the technician laid them out on a work table and determined that one of the connecting rod cap bolts did not have the remains or any evidence that the cotter pin was installed. (Refer to illustration number 2.) The submitter suspects the cotter pin was not installed during the previous assembly which allowed the nut to back off inducing "hammering" and transferring the entire load to the remaining bolt. The bolt head was broken, and the bolt threads relatively undamaged compared to the other bolt threads.
